TetraKO next generation gel saves a local community church with remarkable defensive attack.

FIRE INCIDENT REPORT #3:

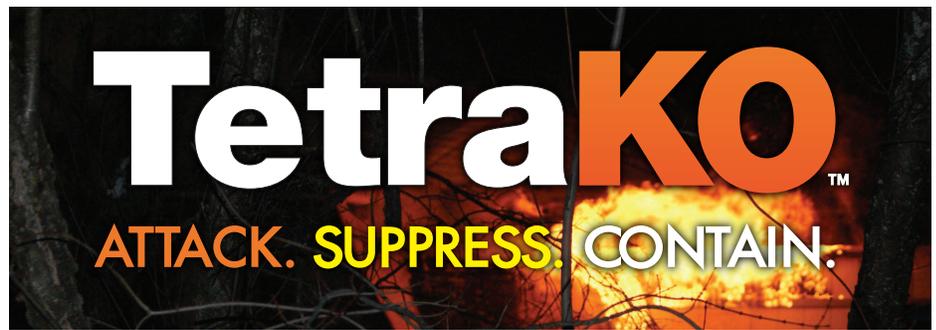
While an aerial apparatus is establishing a defensive attack position on this working fire that had already extended through the building's roof, SBM fire fighters applied TetraKO using a single 1 3/4-inch pre-connected attack line from engine 11. Because heavy snow cover limited access to the C/D corner of the fire, firefighters were forced to conduct a defensive attack applying TetraKO near the opposite end of the building with no direct access to the burning area. Due to the steam conversion of the TetraKO, the fire is, nevertheless, extinguished before supply lines are even established or the aerial is able to flow water. The result is that the church building and much of its contents are saved, with minimal water damage and the fire was controlled in 15 minutes.

After initially hitting the fire and hot spots with TetraKO, I advised division command to discontinue application and allow TetraKO's steam conversion to occur. Almost immediately, the steam cloud increased, dramatically in size, and remained for an extended period of time. Crews continued to monitor and listen with no further evidence of fire.

The following day, four other chiefs and I – with 112 years of collective experience – conducted an inspection of the site. We were amazed that this building did not go to the ground!
